Tree Risk Assessment: Soule Park Town of Freeport

Michael R. Hughes, RCA, BCMA, TRAQ
Hughes Inc. Arbor and Land Mgmt.
284 US Route One
Freeport, ME 04032
7-28-19

RE: Soule Park and French School area trees.

Assignment: Provide a Level 2 Basic Tree Risk Assessment of trees which may pose a risk to the park and the school playground area. Note: It was determined to conduct a Level 3 Advanced Tree Risk Assessment of several trees of concern.

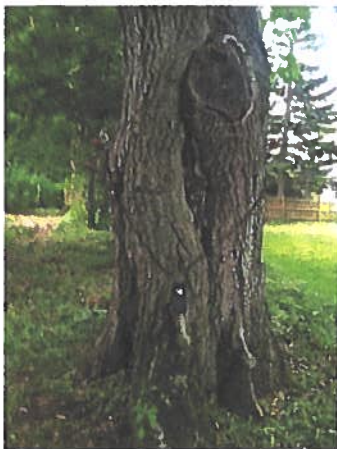
Fig. 1: Tree Check sonic sounding device attached to Subject tree #11 (red oak).

The two extremely mature Subject trees (#11 and #12), pose a significant problem for the site. There are indications (fungal conk) of internal decay and advanced sonic wave testing indicate there is a potential for significant internal decay (all testing took place within 6' of the ground).

10	White ash	School playground	Moderate	Remove low 4" limb back to main trunk	7/22/2019
11*	Red oak	Park trail, School playground	Moderate	Erect fence. Remove tree. Prune to reduce spread and large deadwood	7/22/2019
12*	Red oak	School playground	Moderate	Move swingset. Remove tree. Remove large deadwood	7/22/2019
13*	White pine	School playground	High	Remove tree	7/22/2019
14	White pine	Park trail, School playground	Moderate	Prune to remove hanging limbs and deadwood	7/22/2019
15	White ash	School playground	Low	Prune lower deadwood	7/22/2019
