Phase I Environmental Site Assessment

**Portion of Map 22 Lot 63,
to be donated to the Town
of Freeport, Maine**

December 2020

Site Location Plan
 Portion of Map 22 Lot 63 to be donated to Town of Freeport
 Pownal Road, Freeport, Maine

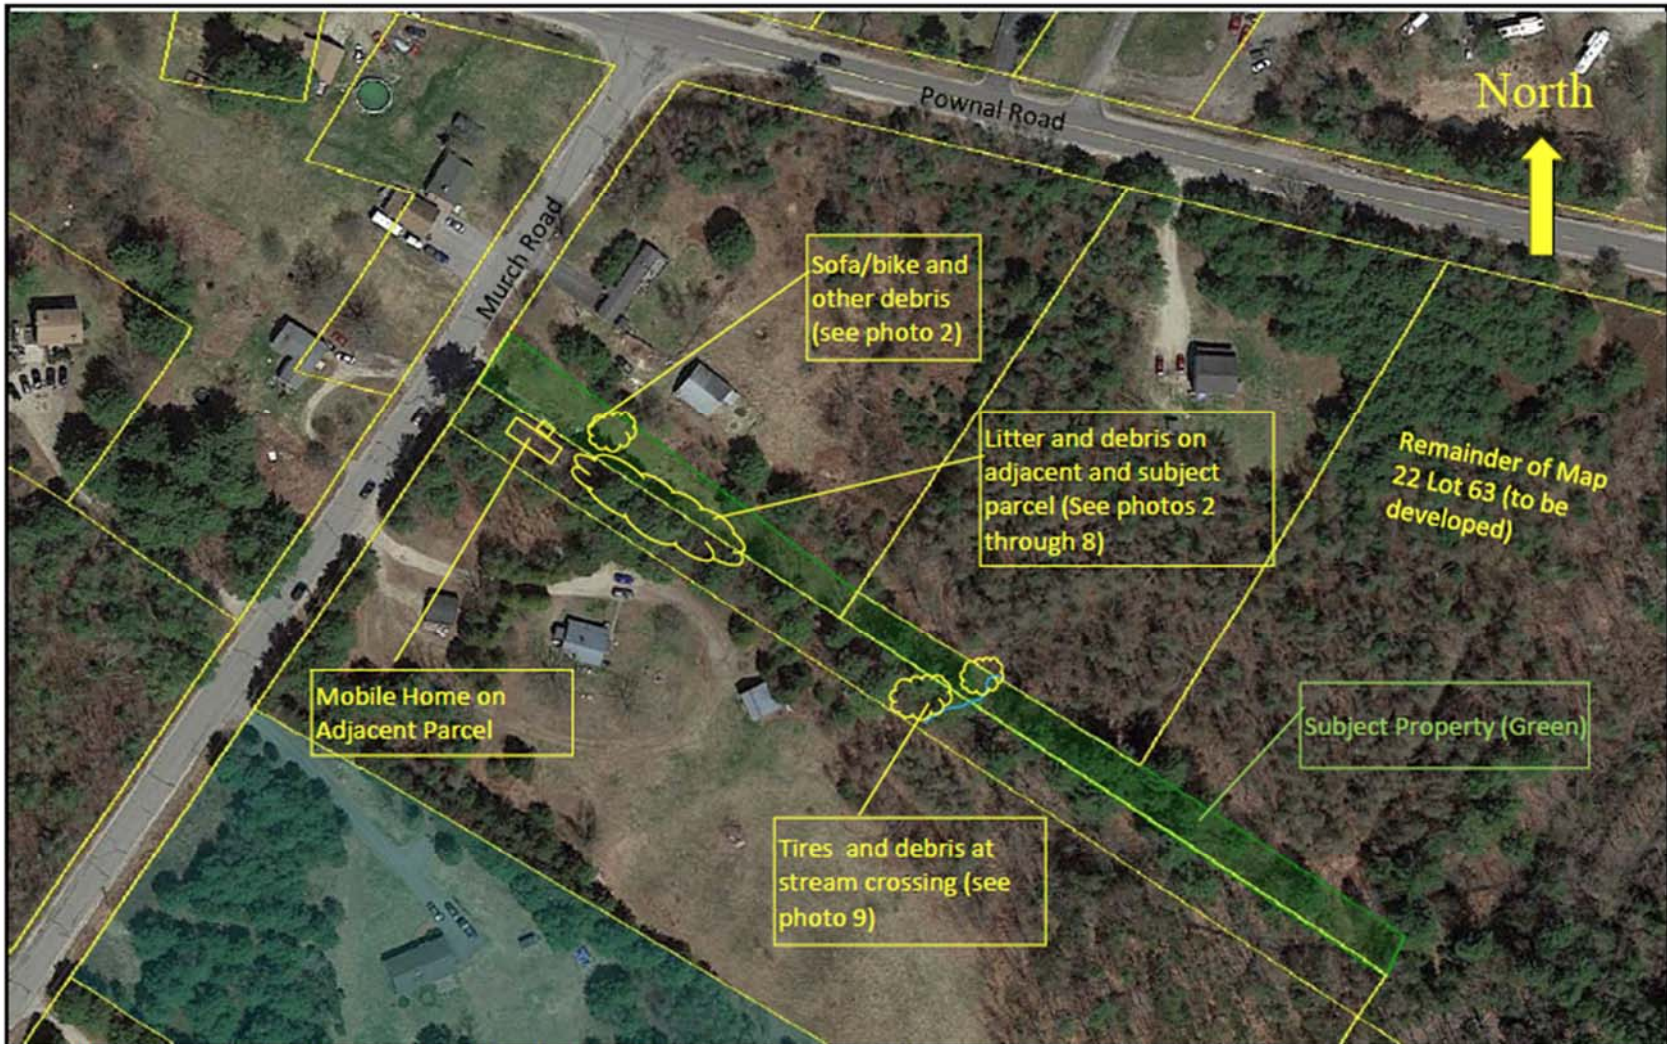
Site Layout	Figure No.
	Portion of Map 22 Lot 63 to be donated to Town of Freeport Pownal Road, Freeport, Maine	2

Figure 1 shows the location of the facility on a USGS topographic quadrangle. Figure 2 is a Site Layout showing buildings present on site. No oil, universal waste, hazardous waste, or hazardous materials were observed to be present at the site. Figure 2 also provides locations for key findings associated with this ESA.

Parcel Lines from Town of Freeport kmz files 11/28/2020. Base map from Google Earth
