Coastal Bluffs

Classification and Mapping of Maine's Coastal Bluffs

Freeport Quadrangle, Maine

Open-File No. 19-5
2019
This map supersedes Open-File Map 02-188.

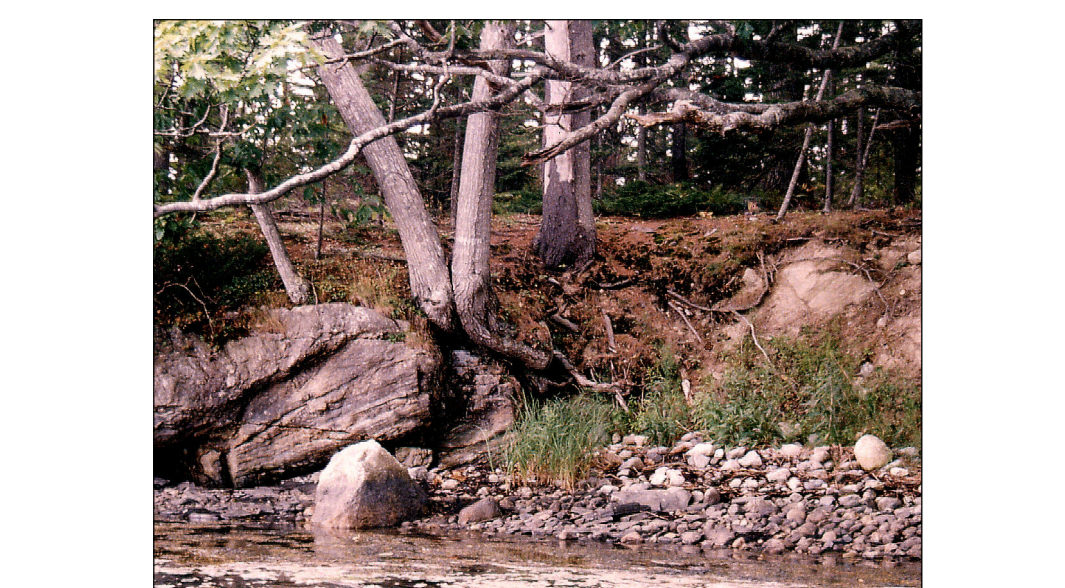
Map Resolution

Since these are regional maps, some shores mapped as stable may contain small areas that are unstable. A bluff, too small to appear on the map, is shown in the photo. This bluff exhibits the characteristics of an unstable bluff: curved tree trunks, exposed roots, and bare ground on a steep slope. It is an area to be concerned about on a local scale. However, this degree of detail is not shown on the map above.

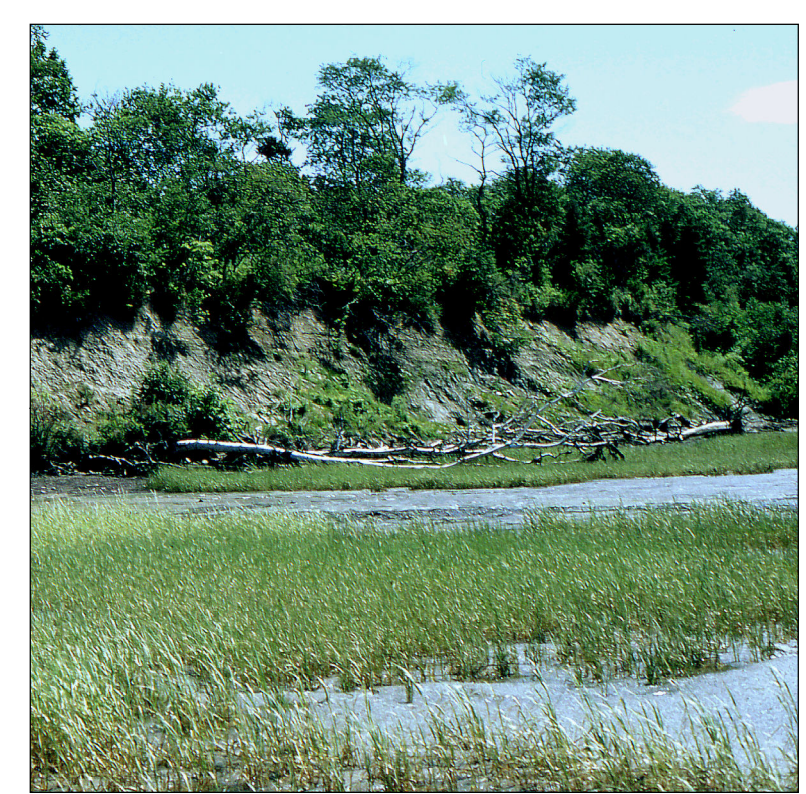
Highly unstable bluff with an unvegetated bluff face and a salt marsh shoreline. Sediments on the bluff face are exposed and fallen tree trunks lie at the base of the bluff. A salt marsh has recently formed on the tidal flat, partly on the top of an old landslide deposit.

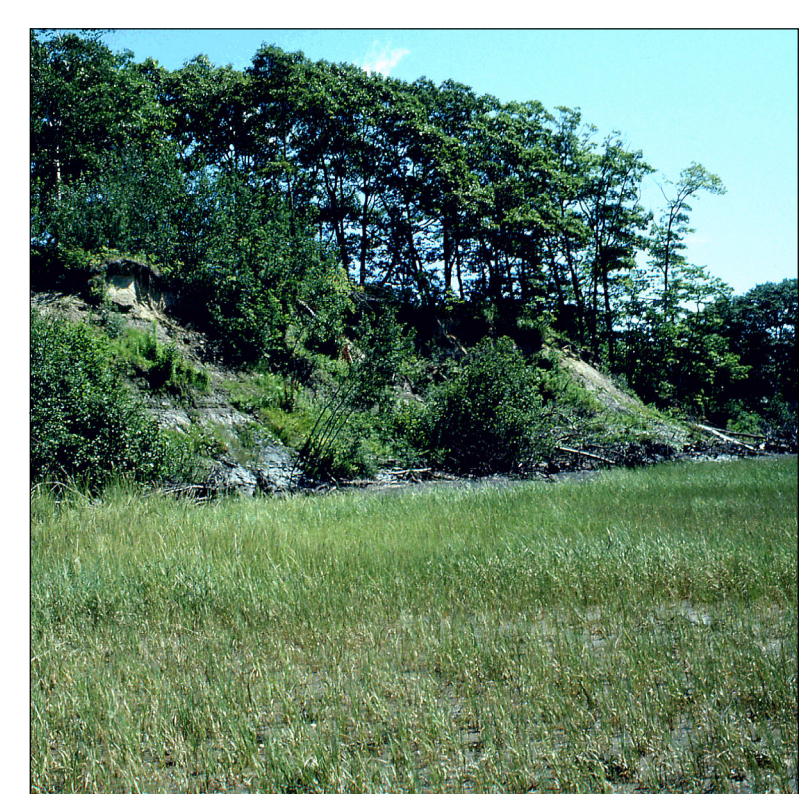
Unstable bluff with a partially vegetated bluff face and a salt marsh shoreline. This bluff, protected by a salt marsh, remains unstable. There are small bushes on the bluff as well as small non-vegetated areas that indicate continuing bluff retreat.

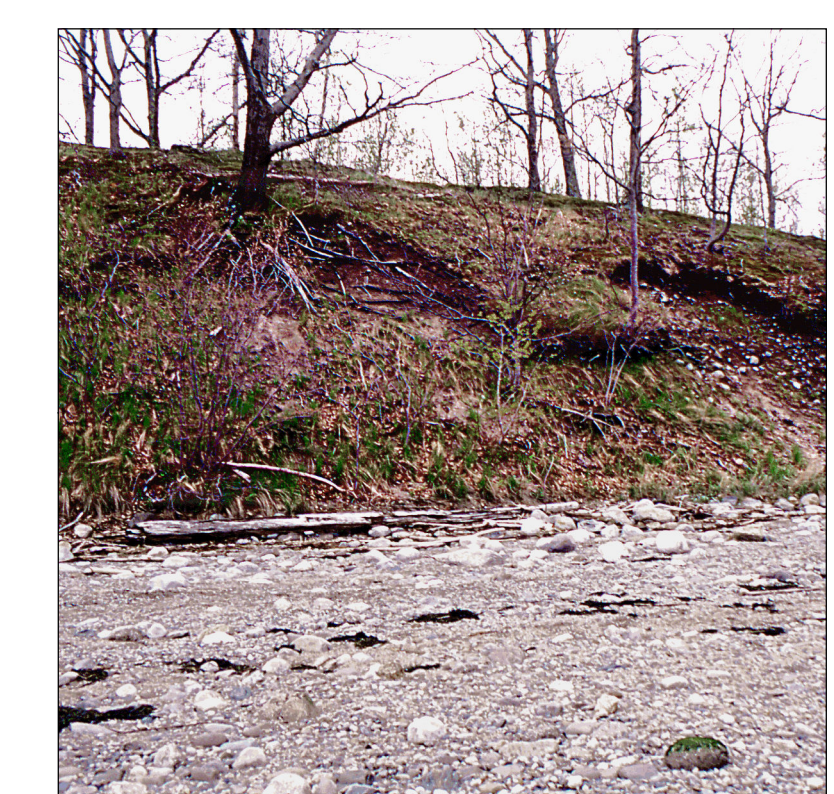
Unstable bluff with a partially vegetated bluff face and a beach/gravel flat shoreline. Slump scars on the bluff face expose sand, gravel, and roots. Fine sediments are removed by waves and currents, leaving gravel to form a beach at the base of the bluff.

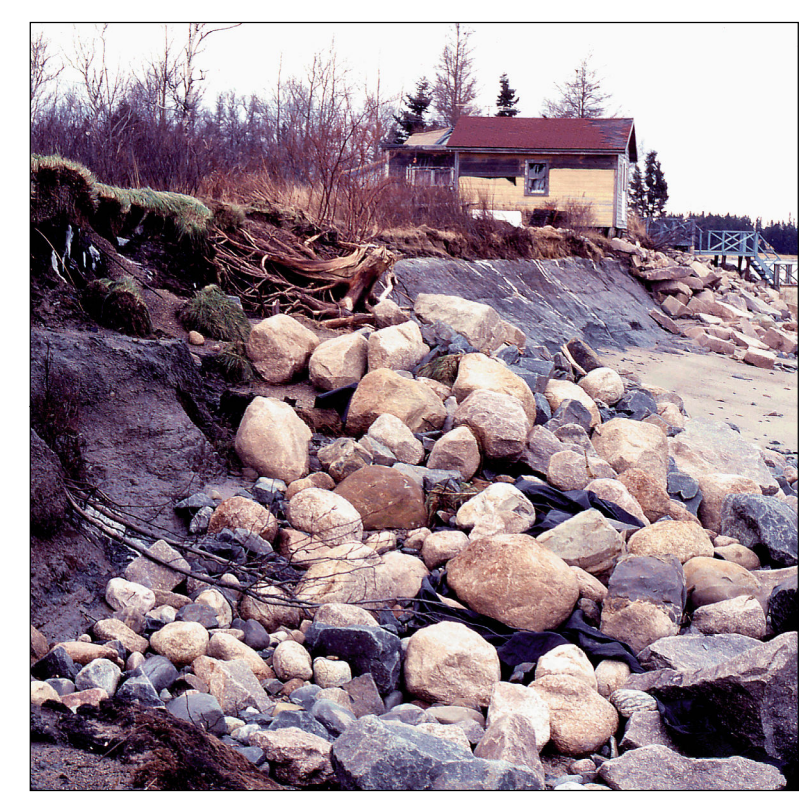
Highly unstable bluff with an unvegetated bluff face and an armored shoreline. This armored bluff is eroding despite an effort to shore it up with riprap, or loosely piled stone blocks. Maintenance at this site could improve bluff stability.

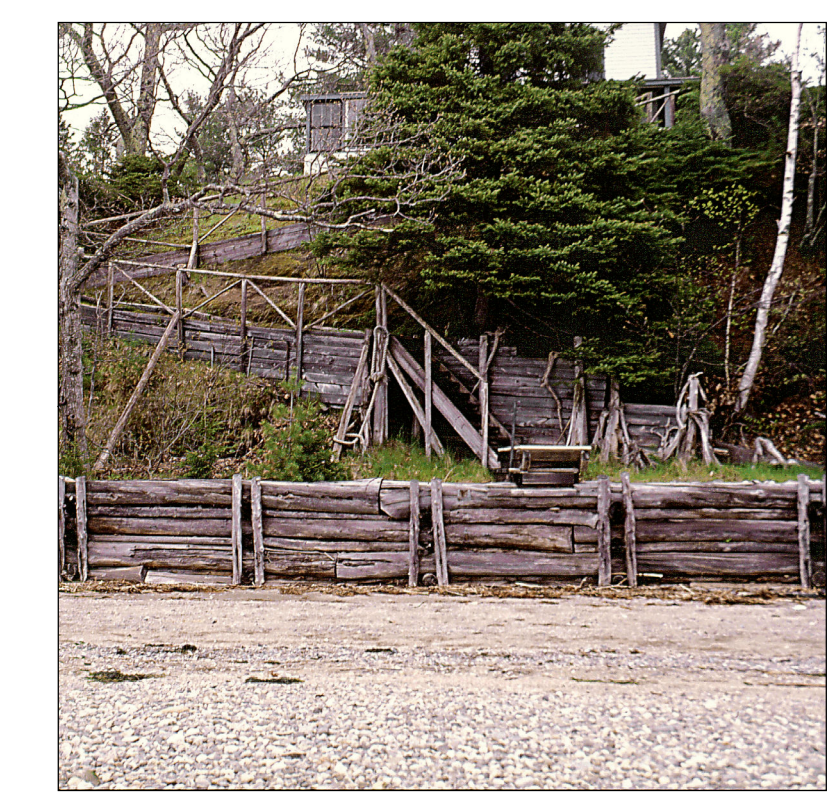
Stable bluff with a vegetated bluff face and an armored shoreline. The bluff face is fully vegetated and supports a mature stand of trees with vertical trunks. The presence of a wooden bulkhead suggests that erosion has occurred in the past.

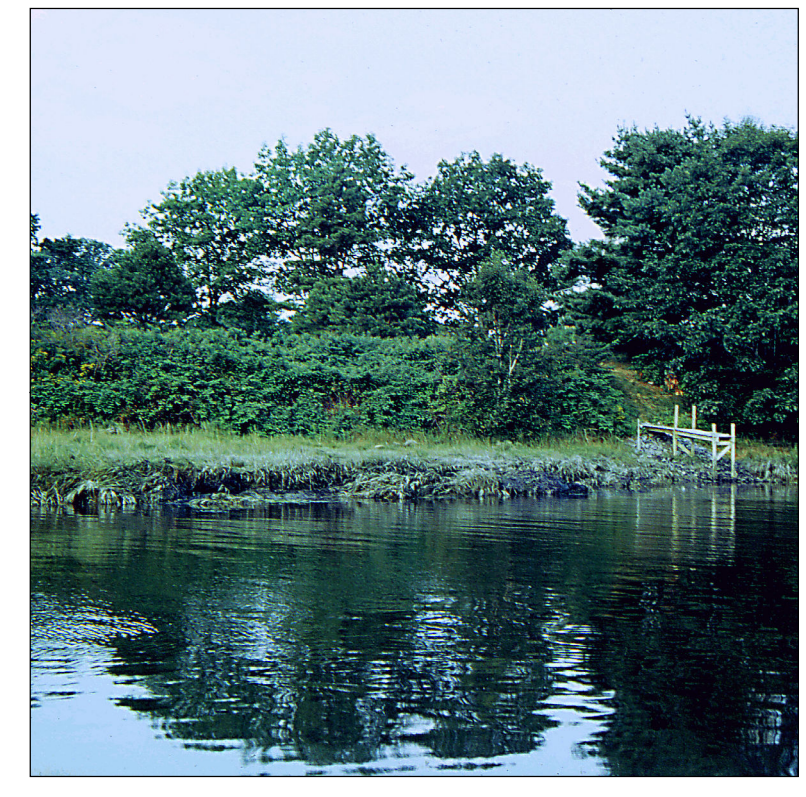
Stable bluff with a vegetated bluff face and a salt marsh shoreline. A low bluff face is covered by shrubs landward of a salt marsh terrace. In this location the mature marsh protects the base of the bluff from rapid erosion and slows bluff recession or retreat.

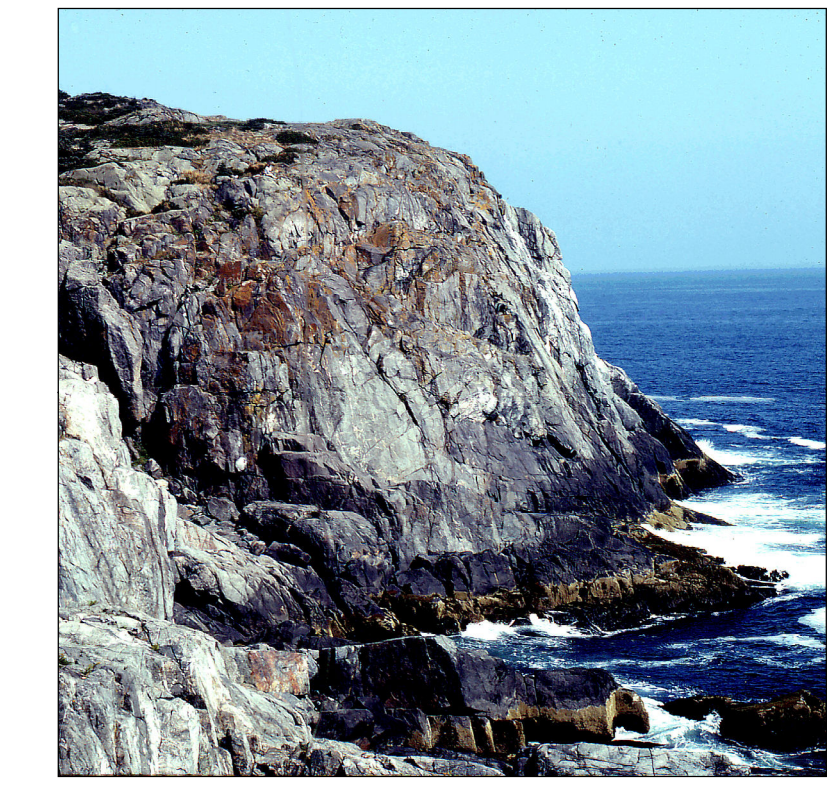
No bluff with a ledge shoreline. A steep slope on the bedrock surface is not a bluff. On this map, bluffs must be made of sedimentary material, generally with 3 feet or more relief. This shoreline type is very slow to change.
