Classification and Mapping of Maine's Coastal Bluffs

Open-File No. 19-5

Types of Bluffs Along Maine's Coast

Freeport Quadrangle, Maine

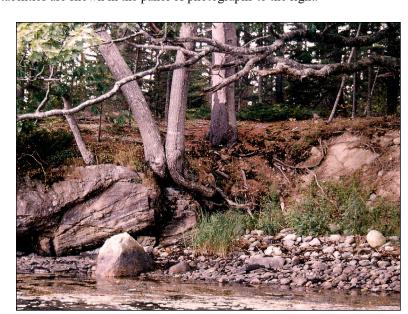
Since these are regional maps, some shores mapped as stable may contain small areas that are unstable. A bluff, too small to appear on the map, is shown in the photo. This bluff exhibits the characteristics of an unstable bluff: curved tree trunks, exposed roots, and bare ground on a steep slope. It is an area to be concerned about on a local scale. However, this degree of detail is not shown on the map above.

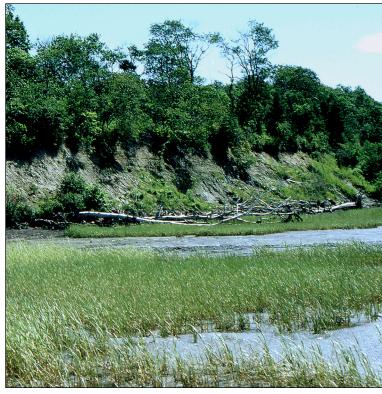
Highly unstable bluff with an unvegetated bluff face and a salt marsh shoreline. Sediments on the bluff face are exposed and fallen tree trunks lie at the base of the bluff. A salt marsh has recently formed on the tidal flat, partly on the top of an old landslide deposit.

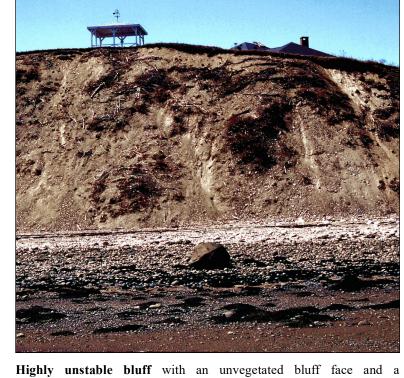
beach/gravel flat shoreline. The bluff face is too unstable to support vegetation. This bluff, a glacial esker, is eroded by waves to create a mixed sand and gravel beach in front the bluff.

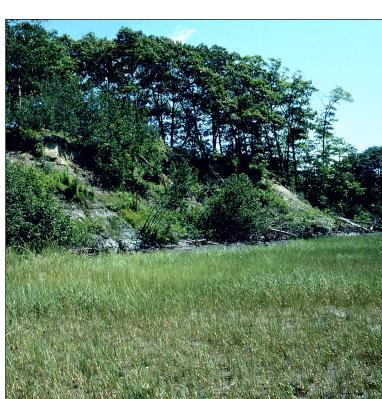
Unstable bluff with a partially vegetated bluff face and a salt marsh shoreline. This bluff, protected by a salt marsh, remains unstable. There are small bushes on the bluff as well as small non-vegetated areas that indicate continuing bluff retreat.

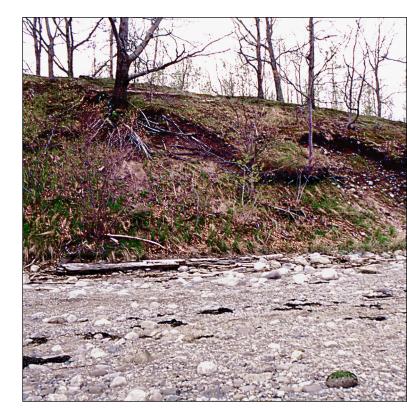
Unstable bluff with a partially vegetated bluff face and a beach/gravel flat shoreline. Slump scars on the bluff face expose sand, gravel, and roots. Fine sediments are removed by waves and currents, leaving gravel to form a beach at the base of the bluff.

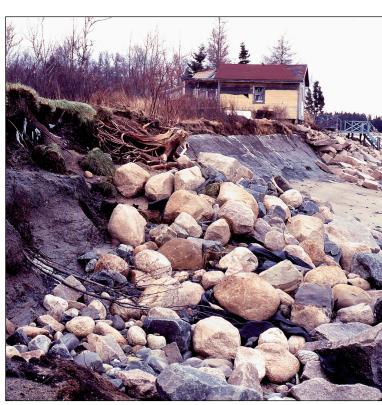
Highly unstable bluff with an unvegetated bluff face and an armored shoreline. This armored bluff is eroding despite an effort to shore it up with riprap, or loosely piled stone blocks. Maintenance at this site could improve bluff stability.

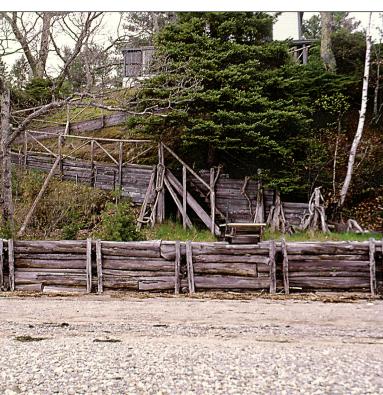
Stable bluff with a vegetated bluff face and an armored shoreline. The bluff face is fully vegetated and supports a mature stand of trees with vertical trunks. The presence of a wooden bulkhead suggests that erosion has occurred in the past.

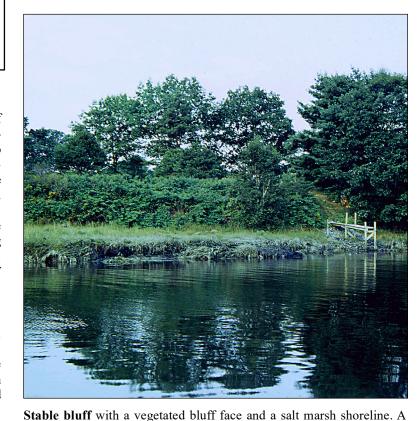
low bluff face is covered by shrubs landward of a salt marsh terrace. In this location the mature marsh protects the base of the bluff from rapid erosion and slows bluff recession or retreat.

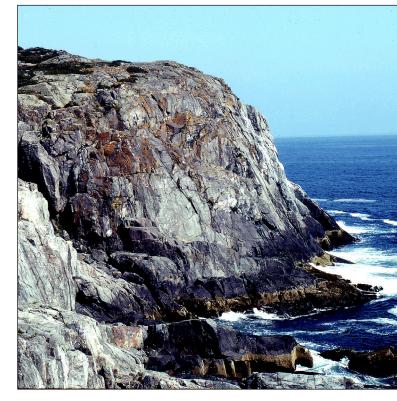
No bluff with a ledge shoreline. A steep slope on the bedrock surface is not a bluff. On this map, bluffs must be made of sedimentary material, generally with 3 feet or more relief. This shoreline type is very slow to
