# Coastal Bluffs

# Yarmouth Quadrangle, Maine

Open-File No. 02-223  
2002

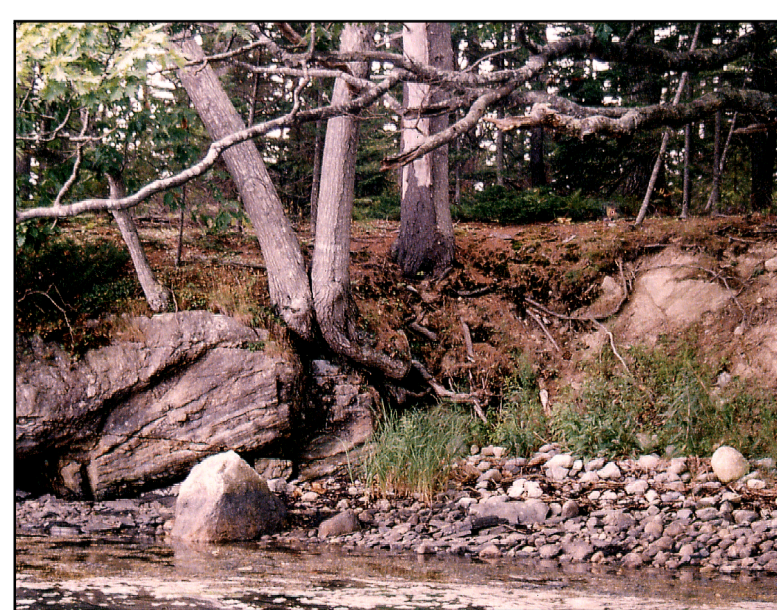
### Map Resolution

Since these are regional maps, some shores mapped as stable may contain small areas that are unstable. A bluff, too small to appear on the map, is shown in the photo. This bluff exhibits the characteristics of an unstable bluff: curved tree trunks, exposed roots, and bare ground on a steep slope. It is an area to be concerned about on a local scale. However, this degree of detail is not shown on the map above.

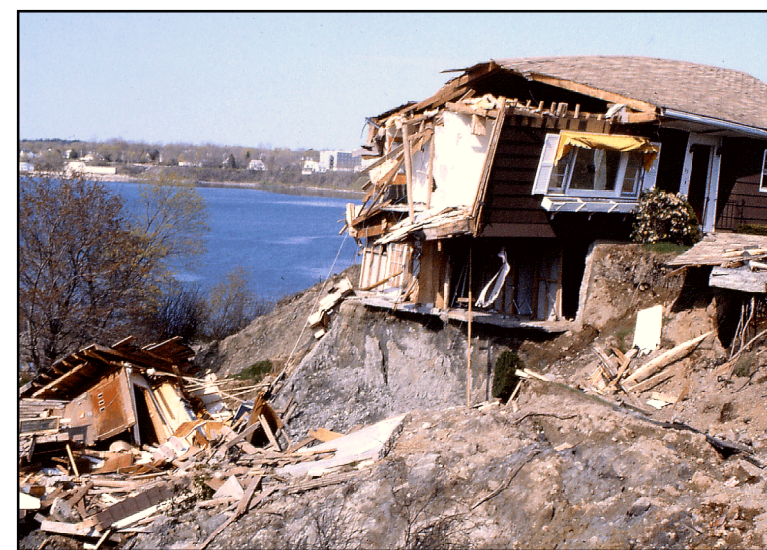
A 1996 landslide in Rockland Harbor (photo below) occurred in an area where the bluff face is classified as unstable. In addition, the bluff had all the characteristics (a-d) listed above. This fact emphasizes that the map above does not indicate sites with a potential for catastrophic landslides. Additional factors need to be considered beyond the appearance of the bluff face and type of shoreline below the bluff. Maps of 1:10,000 scale, surficial sediments, and Coastal Landslide Hazards are available from the Maine Geological Survey to help assess the landslide potential in an area.

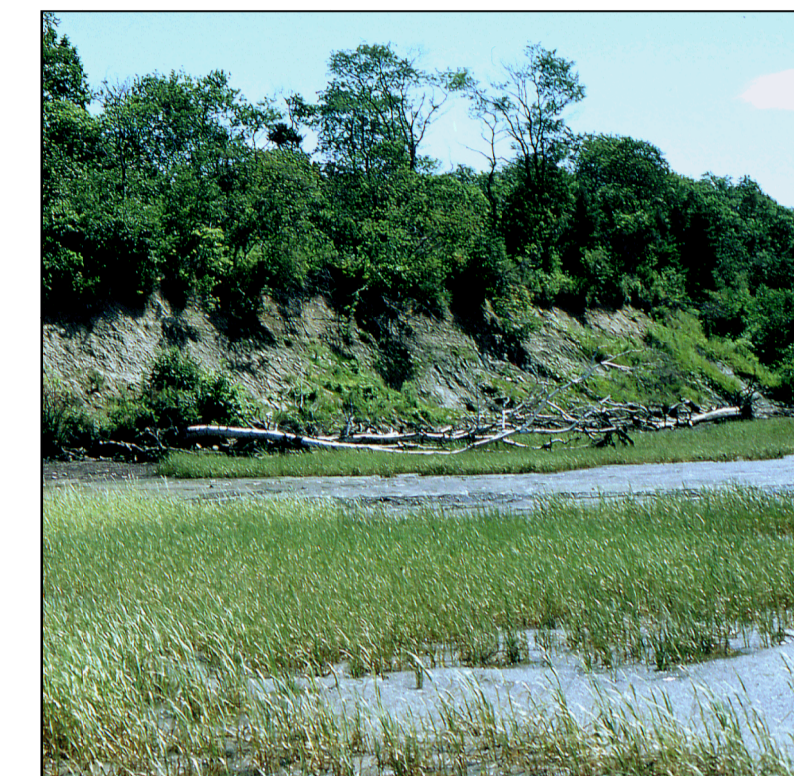
**Highly unstable bluff** with an unvegetated bluff face and a salt marsh shoreline. Sediments on the bluff face are exposed and fallen tree trunks lie at the base of the bluff. A salt marsh has recently formed on the tidal flat, partly on the top of an old landslide deposit.

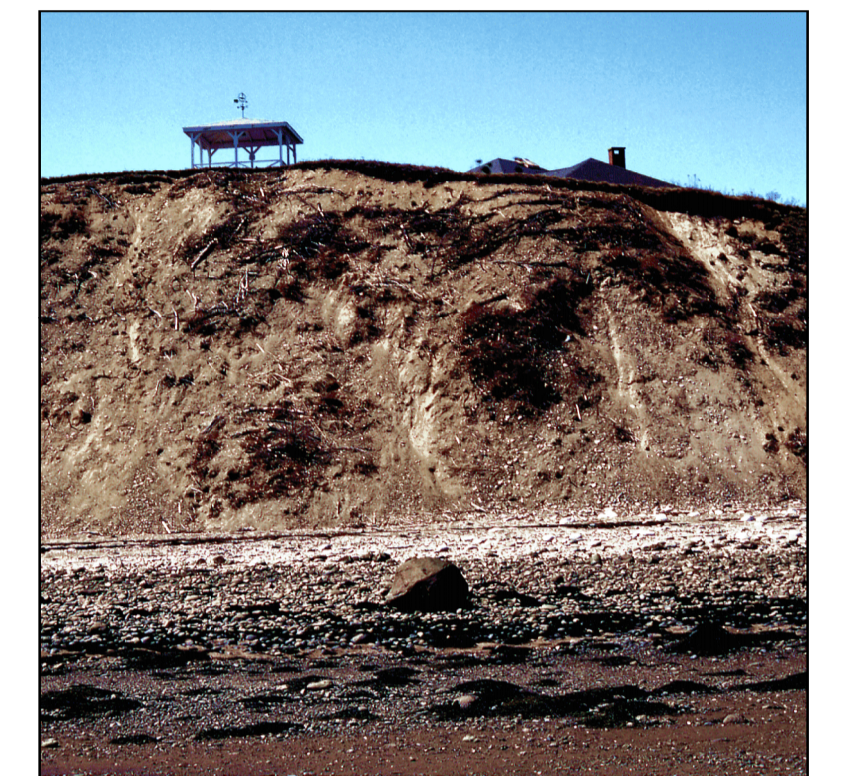
**Highly unstable bluff** with an unvegetated bluff face and a beach/gravel flat shoreline. The bluff face is too unstable to support vegetation. This bluff, a glacial esker, is eroded by waves to create a mixed sand and gravel beach in front of the bluff.

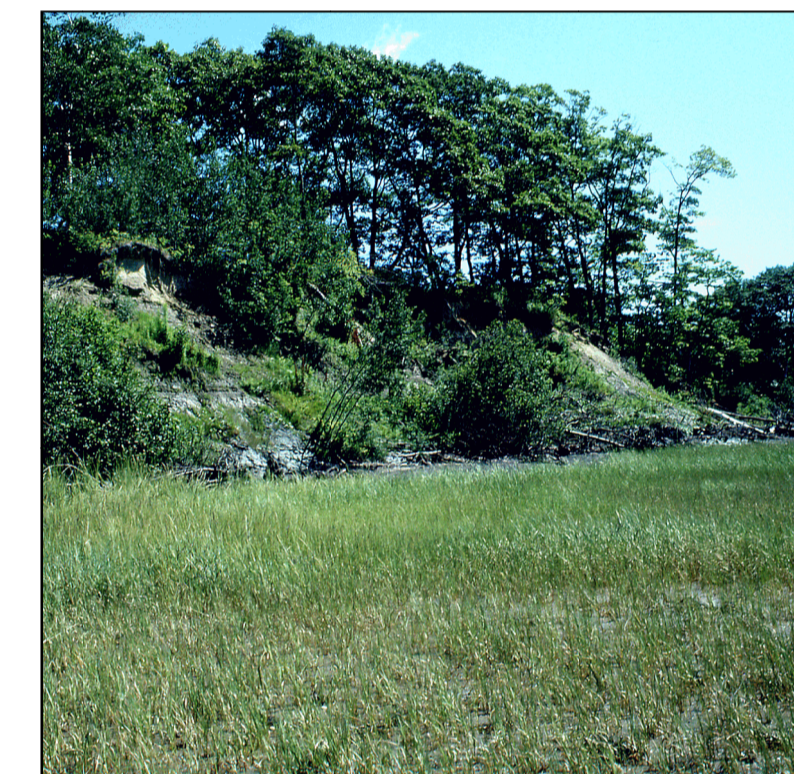
**Unstable bluff** with a partially vegetated bluff face and a salt marsh shoreline. This bluff, protected by a salt marsh, remains unstable. There are small bushes on the bluff as well as small non-vegetated areas that indicate continuing bluff retreat.

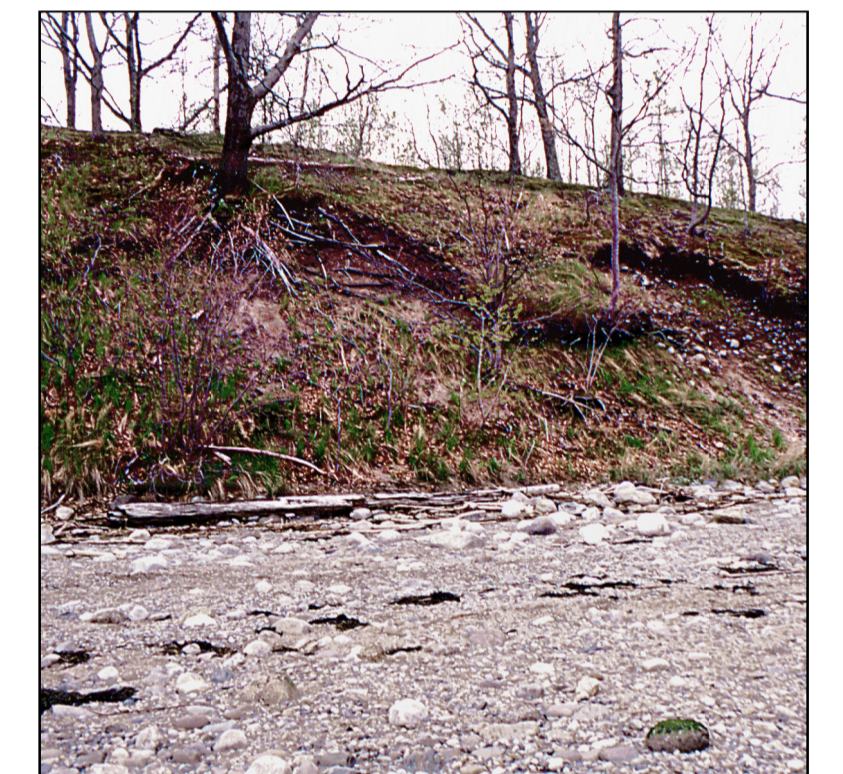
**Unstable bluff** with a partially vegetated bluff face and a beach/gravel flat shoreline. Slump scars on the bluff face expose sand, gravel, and roots. Fine sediments are removed by waves and currents, leaving gravel to form a beach at the base of the bluff.

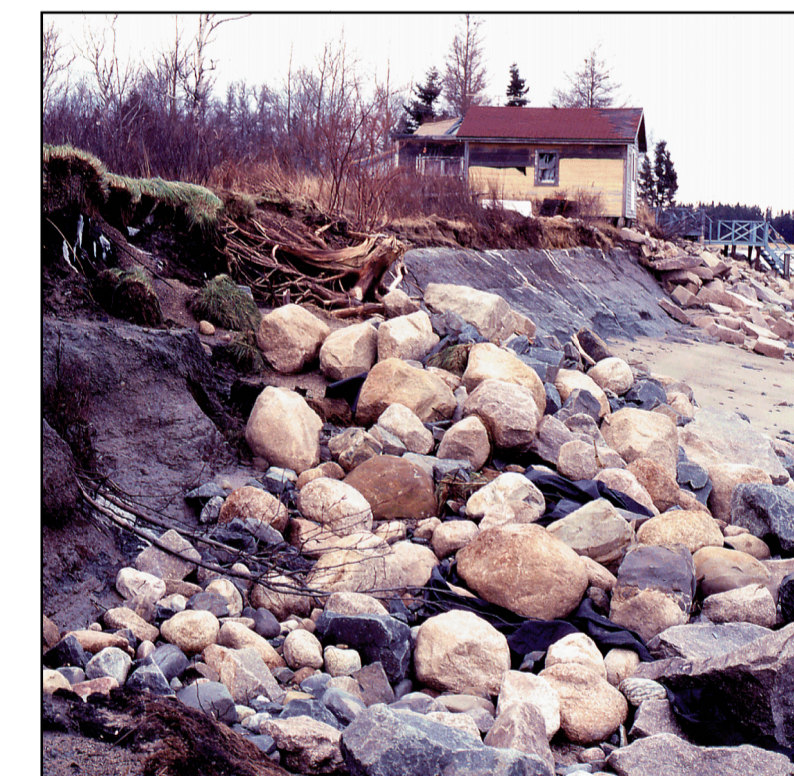
**Highly unstable bluff** with an unvegetated bluff face and an armored shoreline. This armored bluff is eroding despite an effort to shore it up with riprap, or loosely piled stone blocks. Maintenance at this site could improve bluff stability.

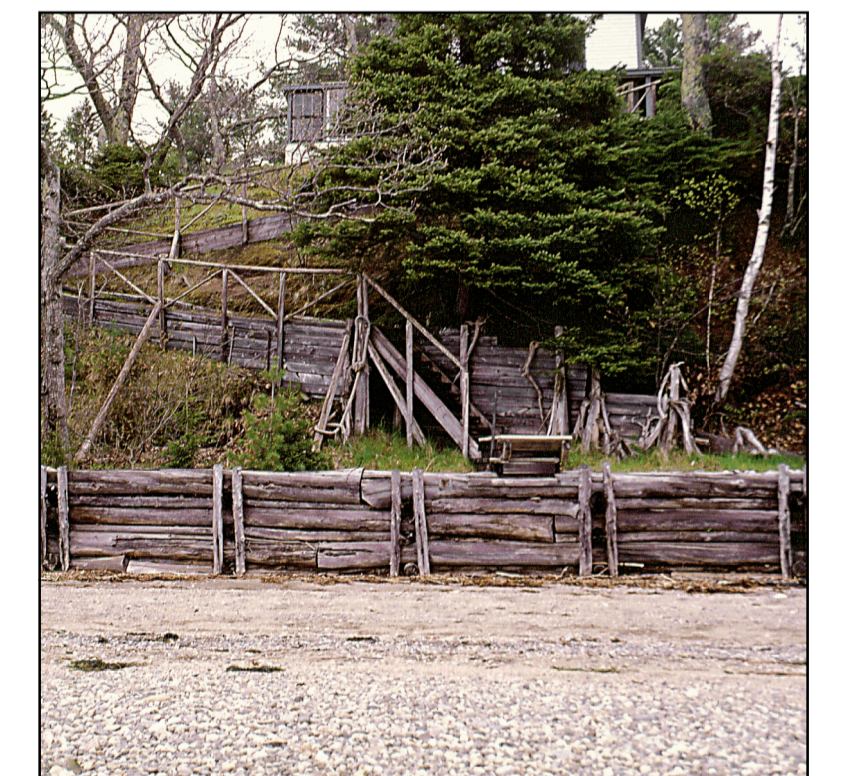
**Stable bluff** with a vegetated bluff face and an armored shoreline. The bluff face is fully vegetated and supports a mature stand of trees with vertical trunks. The presence of a wooden bulkhead suggests that erosion has occurred in the past.

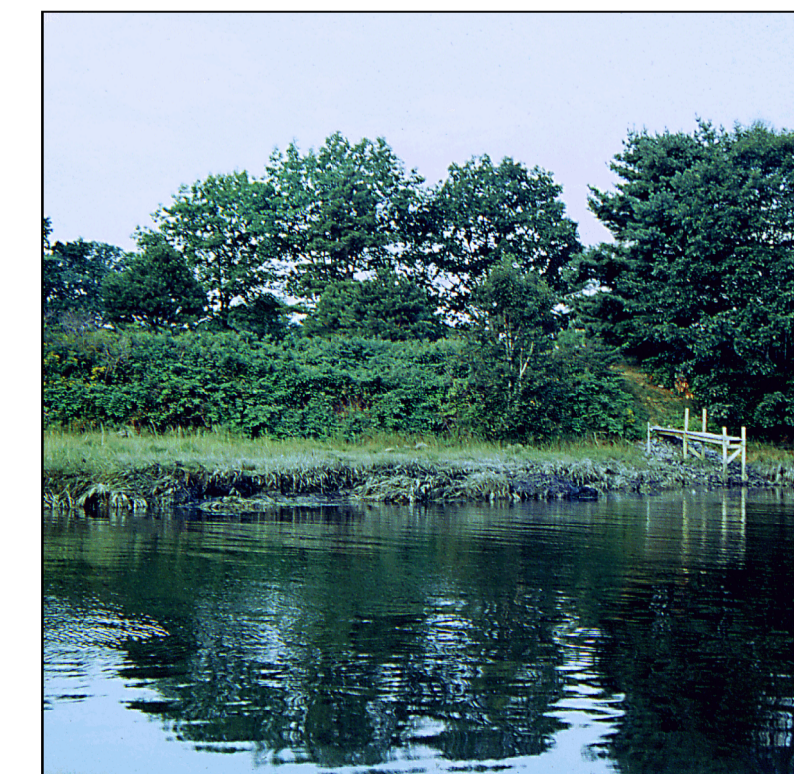
**Stable bluff** with a vegetated bluff face and a salt marsh shoreline. A low bluff face is covered by shrubs landward of a salt marsh terrace. In this location the nature marsh protects the base of the bluff from rapid erosion and slows bluff recession or retreat.
